INVESTIGATION OF HYDROTEST FAILURE
OF THIOKOL CHEMICAL CORPORATION
260-INCH-DIAMETER SL-1 MOTOR CASE

by John E. Srawley and Jack B. Esgar

Lewis Research Center

Start
The Thiokol Chemical Corporation 260-inch-diameter SL-1 ^A motor case failed during hydrotest at a pressure of 542 pounds per square inch, which was about 56 percent of proof pressure. The motor case was constructed of 250 grade ^{FEB} maraging steel plate joined mostly by submerged arc automatic welding. An investigation of the failure was conducted by a Committee composed of members from Industry and Government. Investigation showed that the failure originated from a defect that was not detected by nondestructive testing techniques prior to aging. Nondestructive testing was not conducted between aging and hydrotest. The defect causing the failure was in the heat-affected zone of a longitudinal submerged arc weld on the cylindrical section of the motor case. The area where the defect was located had been repaired by a manual gas-tungsten-arc (TIG) weld. The defect, which was submerged within the vessel wall and oriented longitudinally, was approximately 1.4 inches long and had a width of about 0.10 inch. Four other

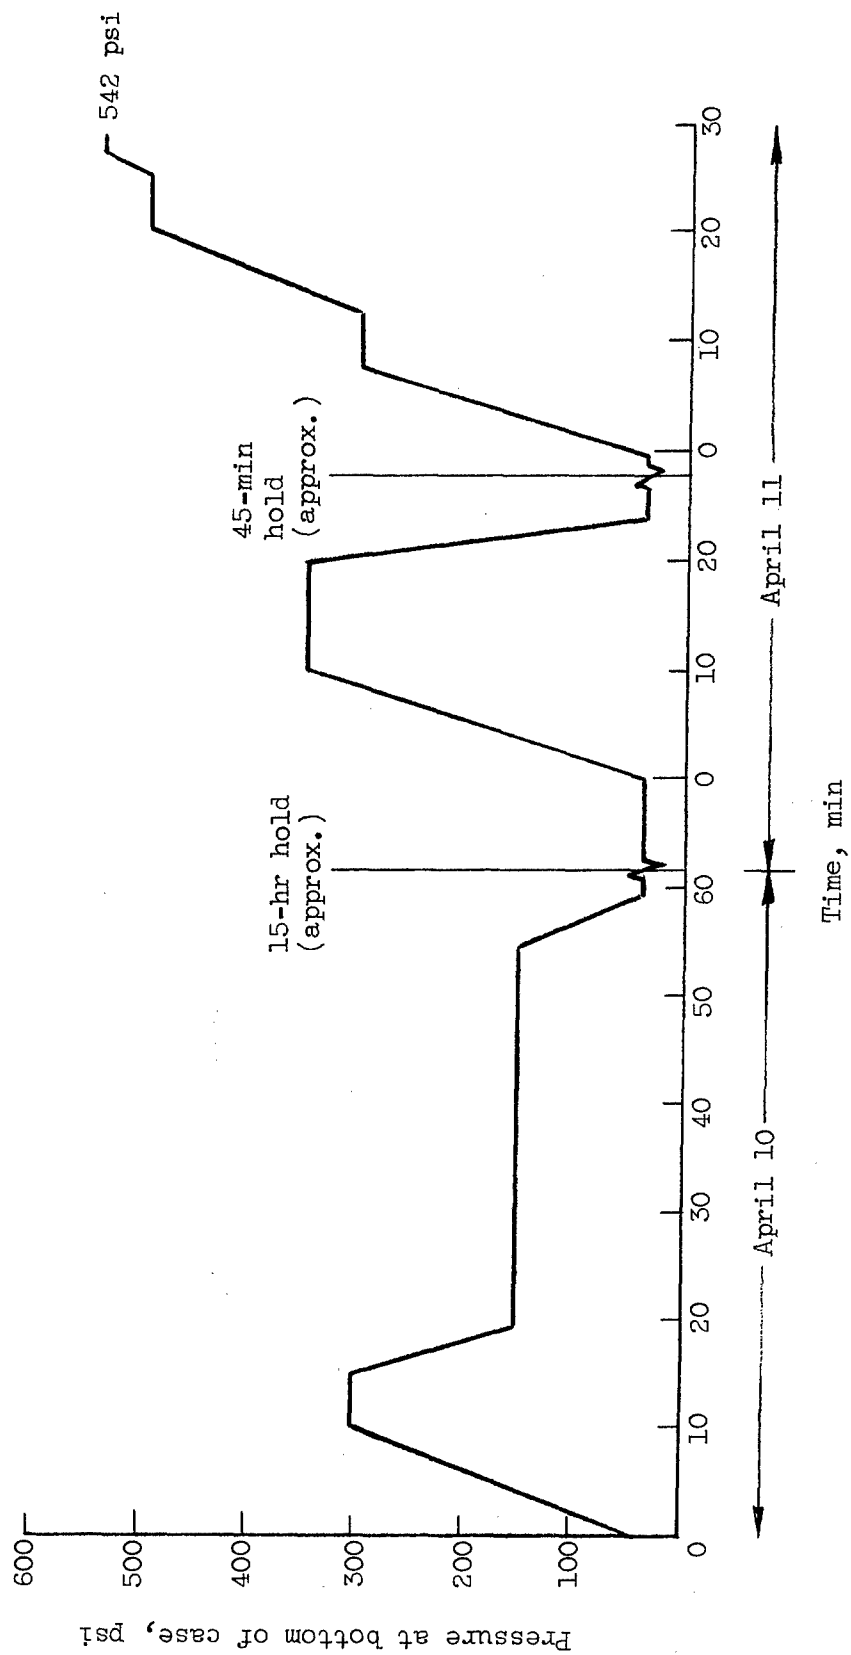
Figure 4. - Pressure-time history during hydrotest.

The maximum hydrotest pressure planned was 960 psi, 10 percent above the maximum expected operating pressure of the motor. The actual pressure-time history for the case is shown in figure 4. The 300-psi pressurization on

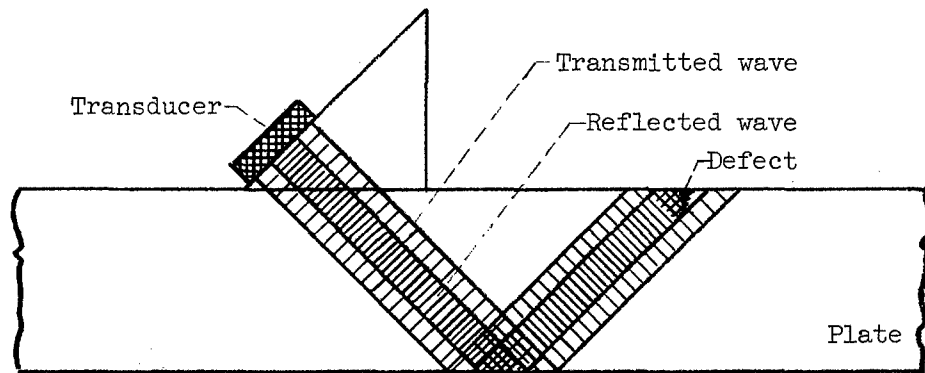
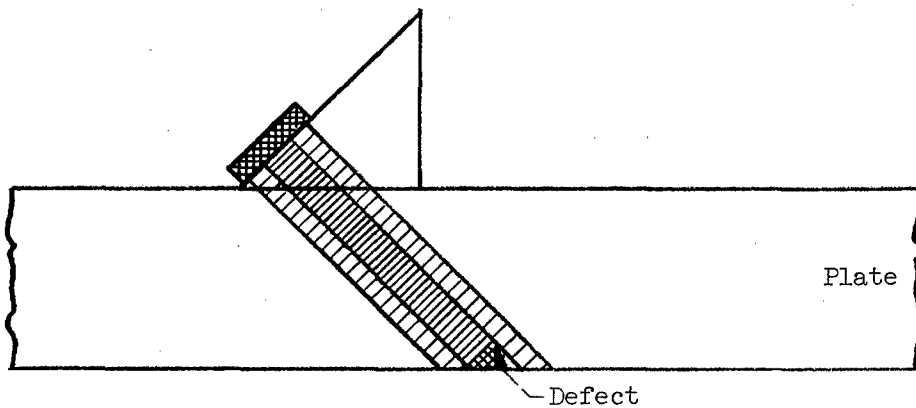
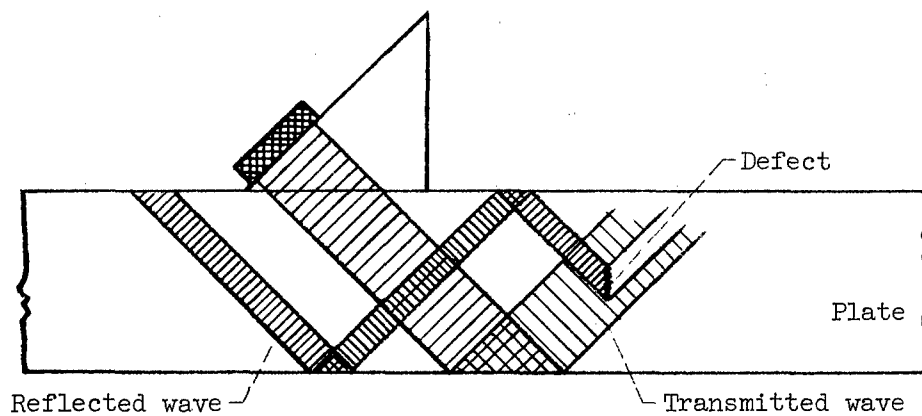
Figure 17. - Effect of defect location on detectability by ultrasonic techniques.

(a) Defect on same surface as transducer.

(b) Defect on surface opposite to transducer.

(c) Defect submerged within plate.

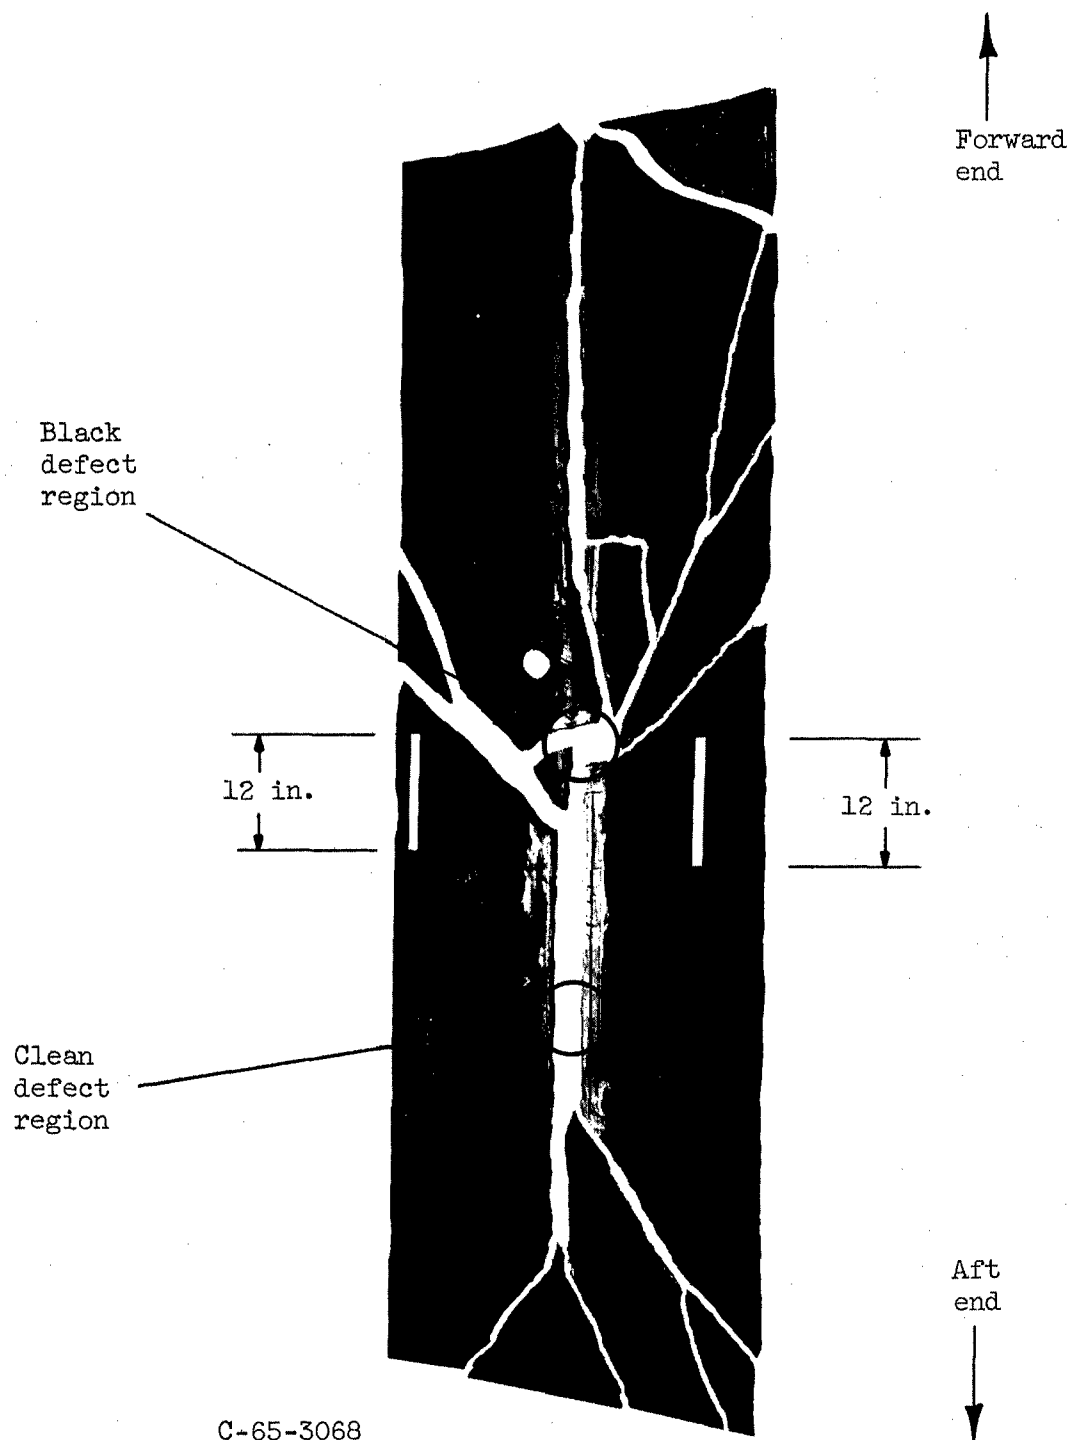
Figure 19. - Plan view of fracture paths (inside surface of motor case shown).

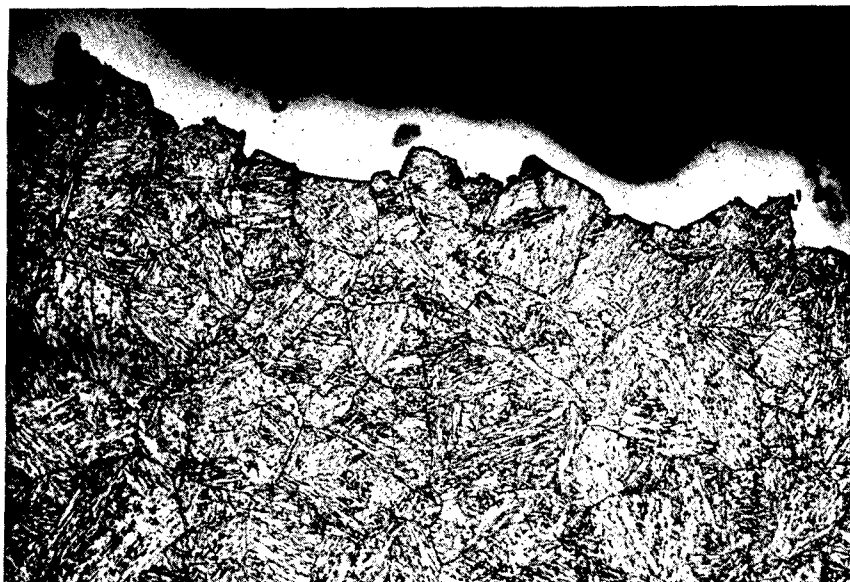
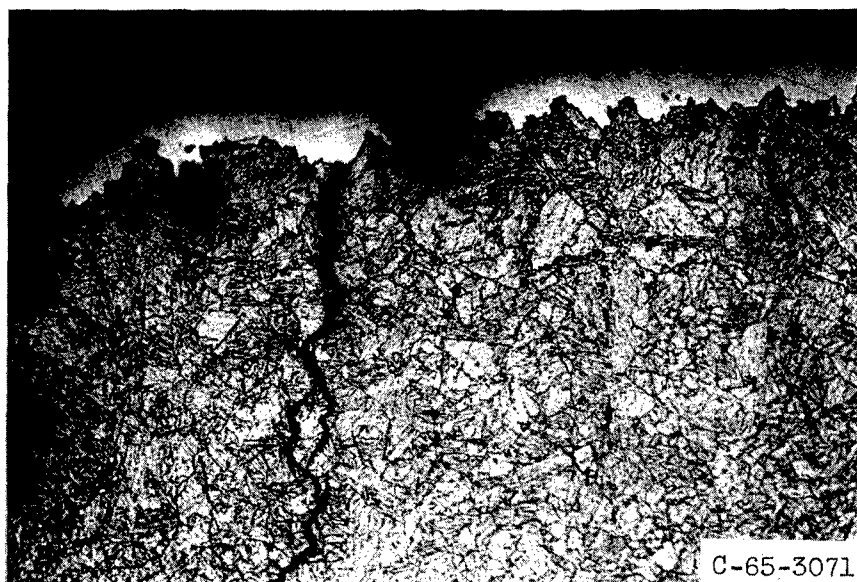
Figure 21. - Fracture profiles of clean defect region
(section B-B of fig. 20(a)). Nital etchant. X200.

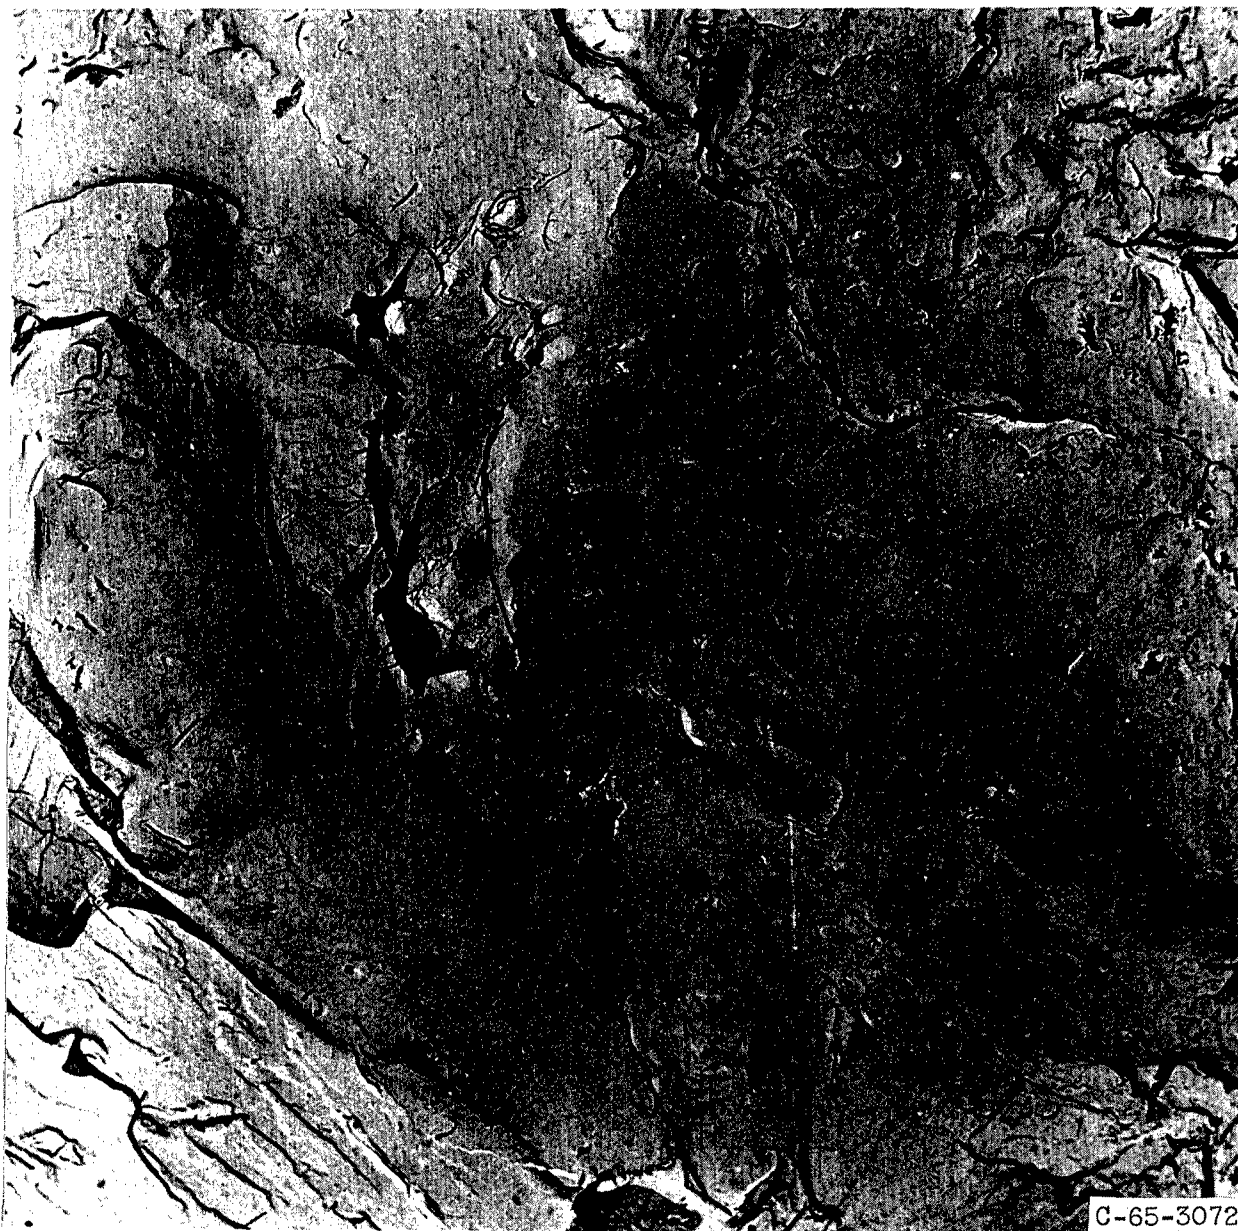
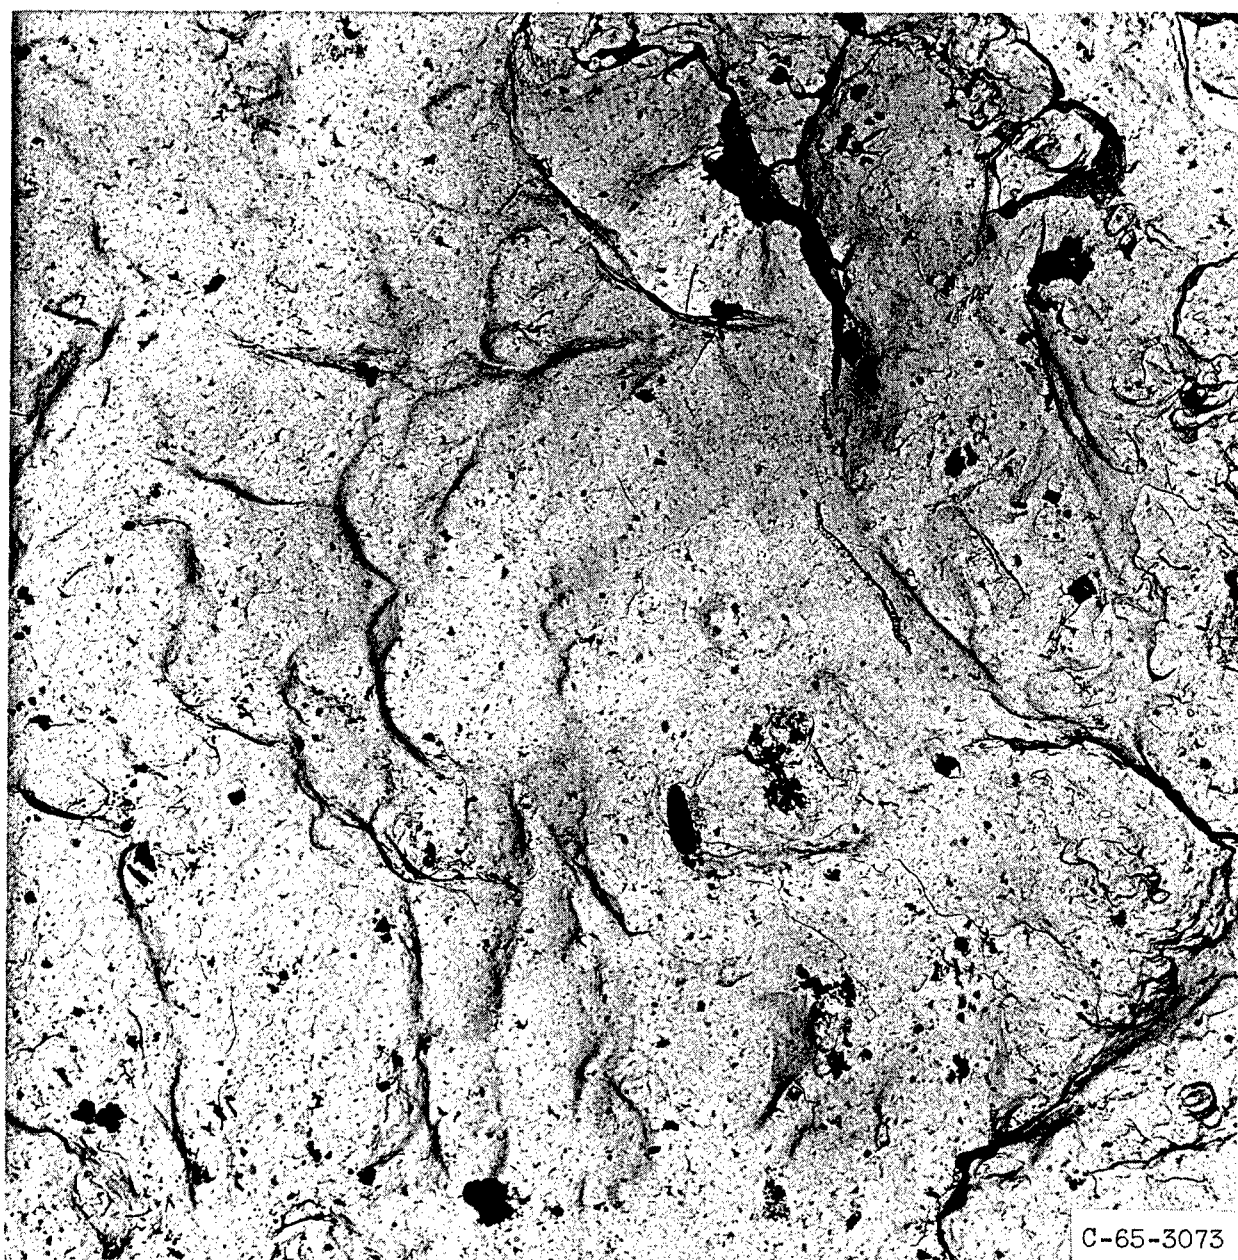
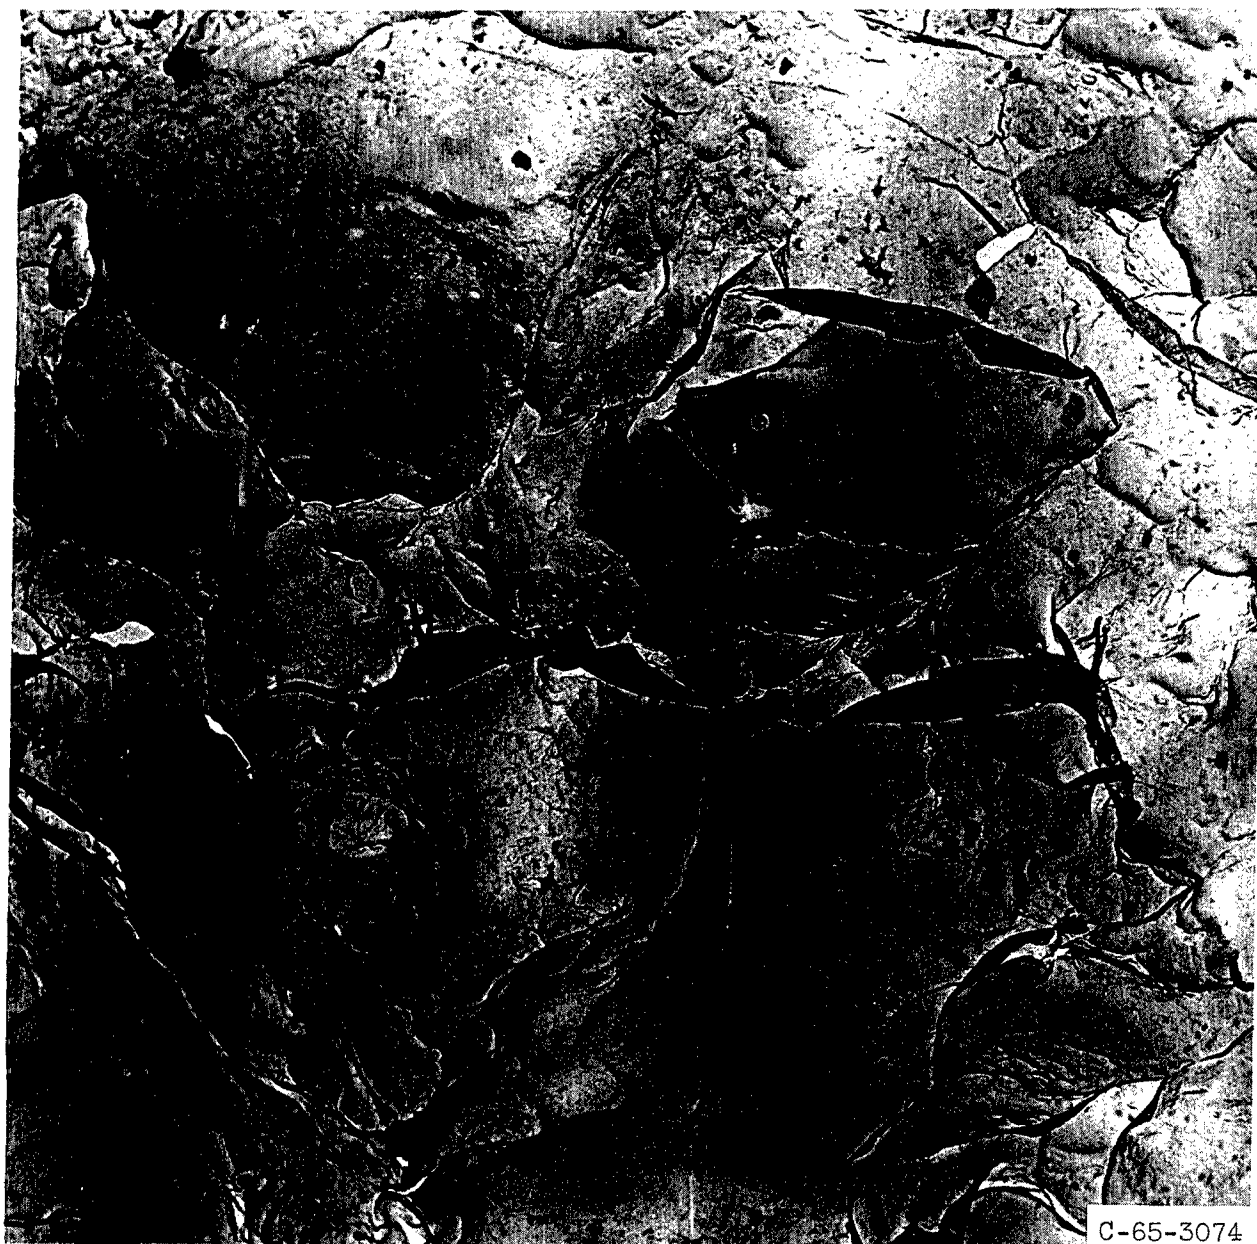
Figure 22. - Fractograph of clean defect. x5000.

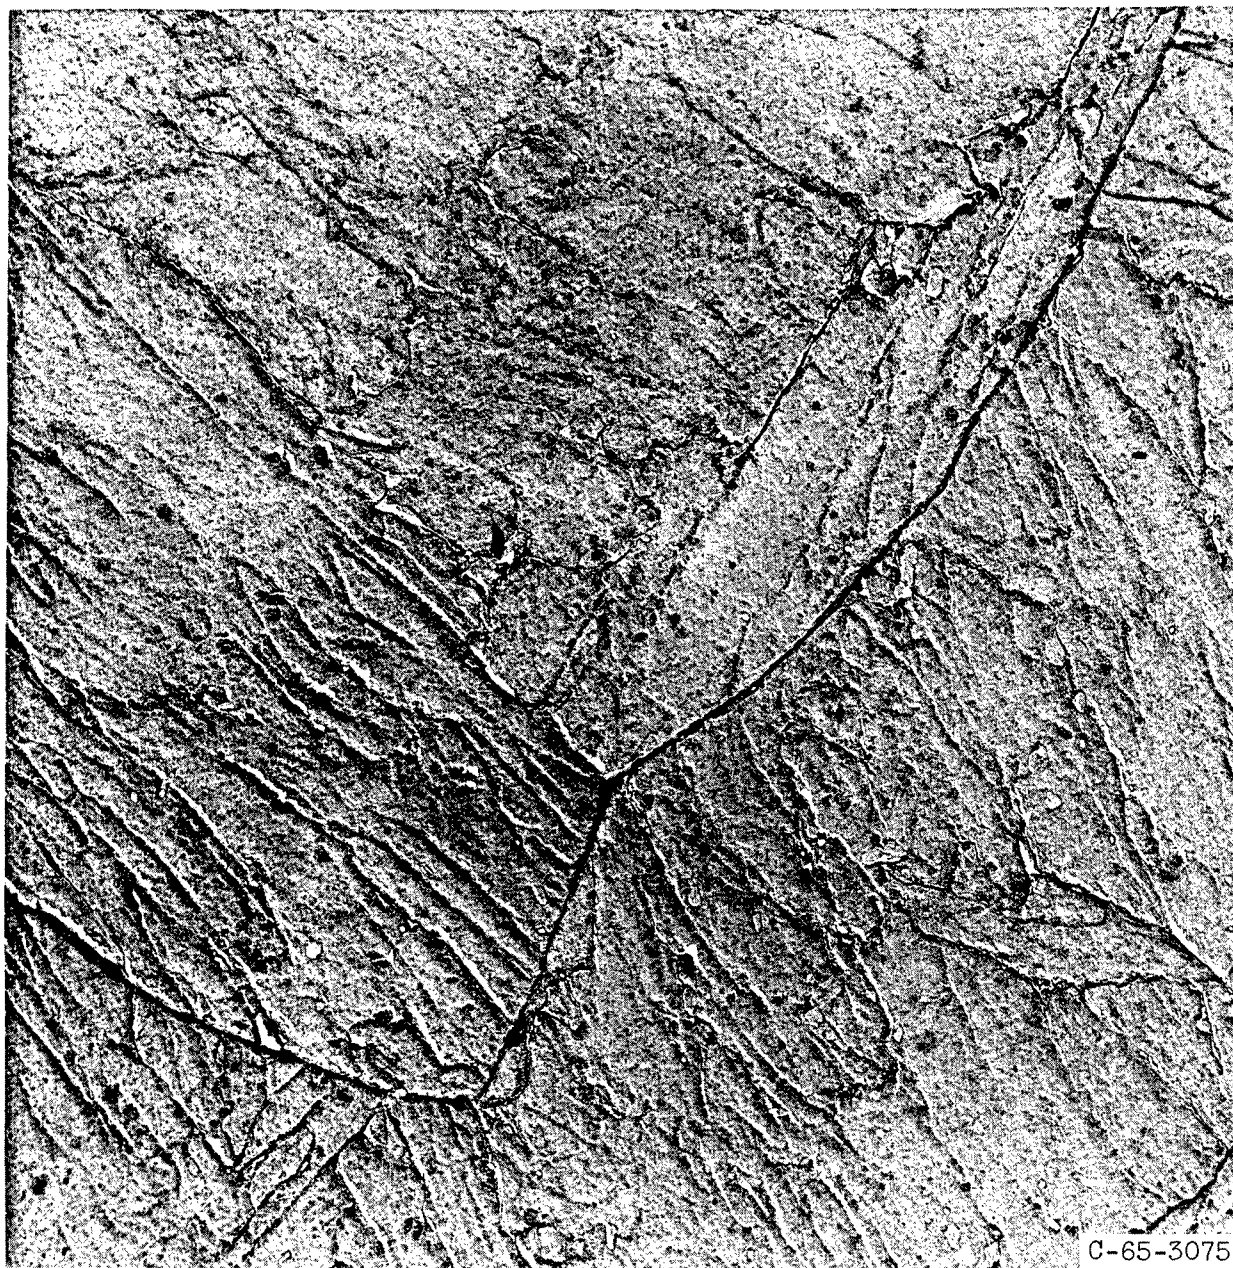
Figure 23. - Replication electron micrograph of area near clean defect.
x12 000.

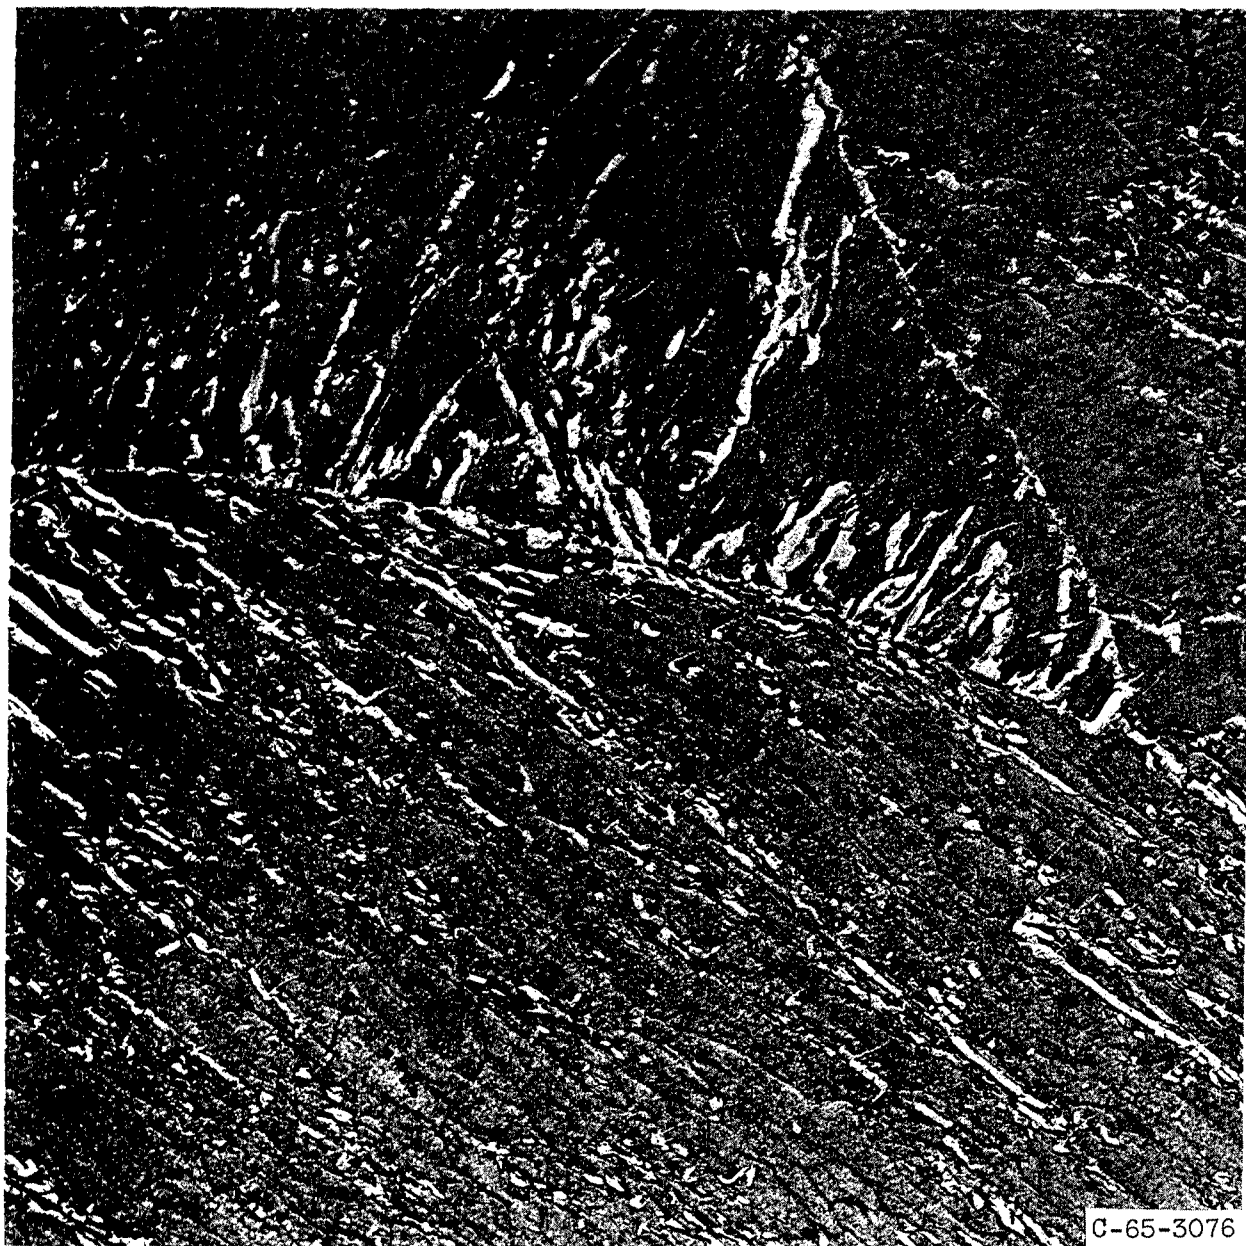
Figure 24. - Replication electron micrograph of region of base plate near subarc weld fusion zone in clean defect region. $\times 10\ 000$.

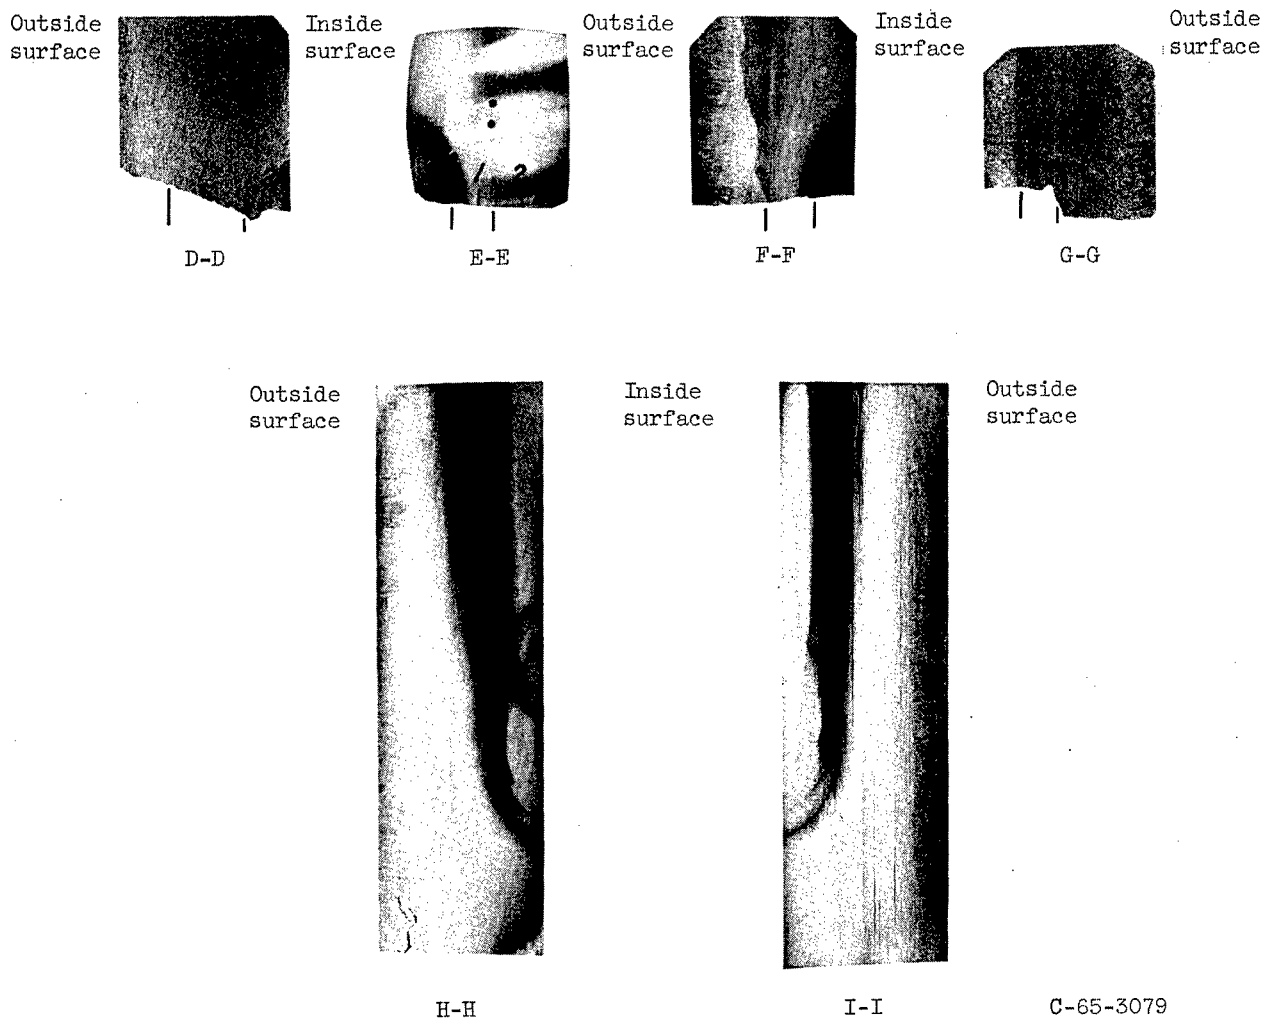
Figure 27. - Cross-sectional views through black defect region (see fig. 25). $\times 1.5$.
(Reduced 17 percent in printing.)

The black defect consists of a region covered with a black film, with fracture lines radiating from it. The defect has an L-shape, and at one point extends to the outer surface of the motor case through a region of the base plate adjacent to the dark etching band of the subarc weld HAZ. The blackened region extends from one side of the subarc weld completely across the weld metal to the base metal on the other side. The markings of the columnar solidification pattern of the subarc weld metal are clearly visible in the black-defect area of the fracture surface. Various sections transverse to the black defect and parallel to the main fracture path are shown in figure 27. The transverse sections (D-D to G-G) show that the entire length of the black defect (the boundaries of which are indicated by the black marks) is located immediately below the dark etching band of the TIG repair. The crack in section G-G can also be seen in the surface macrograph (fig. 25) and was probably generated during the case failure. The parallel sections H-H and I-I show that no flaw similar to the black defect exists at the aft end of the TIG repairs.

Figure 28 shows fracture profiles through the black-defect surface. The black layer between the steel and the nickel plate in figure 28(a) is a plastic mounting compound that seeped under the loose nickel coating during metallographic mounting. Figures 28(a) and (b), which were taken from section E-E in figure 27, show the profile of the grain-coarsened base plate in the region of the subarc weld HAZ. Figures 28(c) and (d), which were taken from section D-D in figure 27, show a region of base plate outside the subarc weld HAZ.

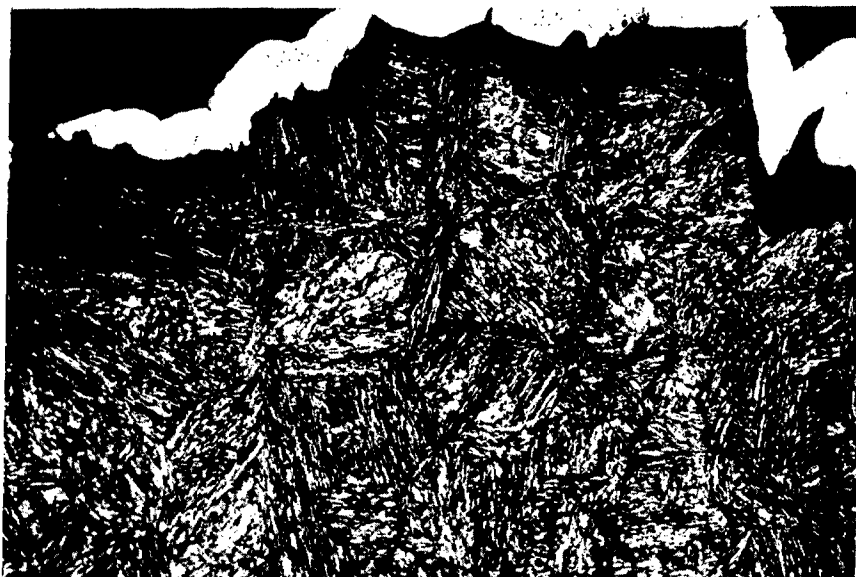
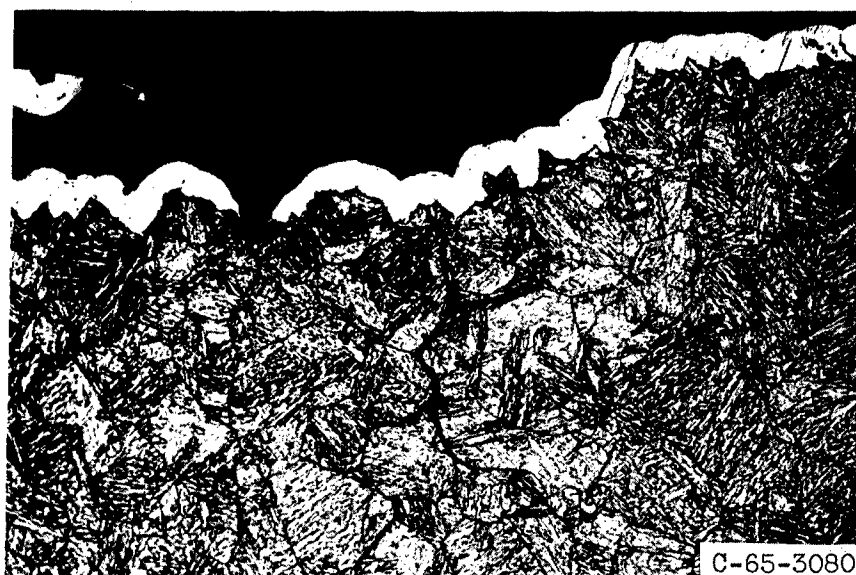
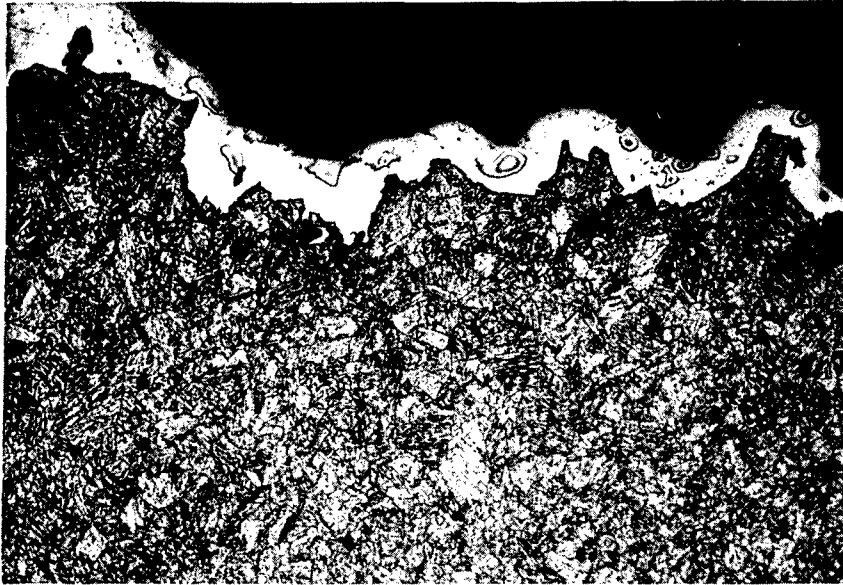
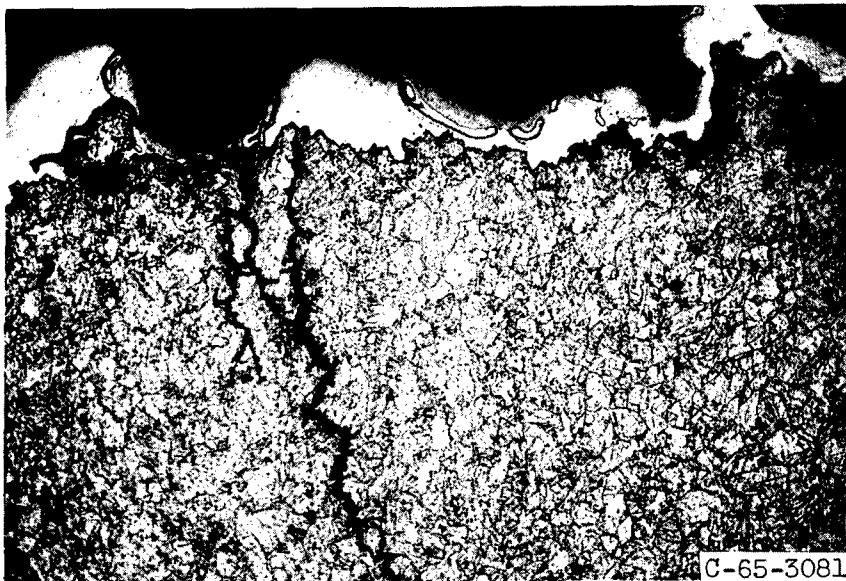
Figure 28. - Fracture profiles of black defect region.
Nital etchant. $\times 200$.

(a) Black defect (from area 1, section E-E, fig. 27).

(b) Away from black defect (base plate, from area 2, section E-E, fig. 27).

(c) From area 1 (section D-D, fig. 27).

(d) From area 2 (section D-D, fig. 27).
